### CENTRAL INTELLIGENCE AGENCY

#### SUBJECT: Harbor Installations at Klaipeda

#### Port Installations

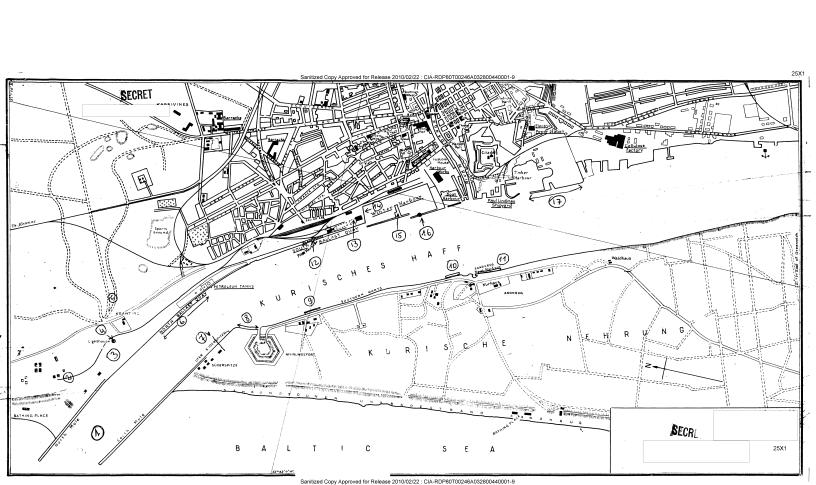
- 1. Wreck and green buoy;
- 2. signal station;
- 3. rangefinder station;
- 4. radio antennas and beacon;
- 5. rangefinder station visible above the trees;
- 6. no wharf;
- 7. wooden launching cradle, probably for a lifeboat (condition unknown);
- 8. ruined wooden pier;
- 9. two wooden piers;
- 10, 11. piers.

Note: these four piers [9, 10, 11] are the only ones alongside which a vessel can be brought,

12. wharf under repair, about 100 meters. This wharf had collapsed.

It is made of pile planks.

- 13. small shipyard
- 14. pilot-boat station
- 15. turrets and mounts (for artillery and antiaircraft guns) dismantled from commercial ships; painted with red lead.
  - 16. small signal station
  - 17. many trawlers
